INSPECTION REPORT FOR

Mr. Smith

LOCATION OF INSPECTION:
123 Any Street
Anywhere
Anywhere, FL 33333

Report prepared by:
Gulfshore Home Inspections, Inc
25334 Pinson Dr.
Bonita Springs, FL 34135
(239) 949-1601
GulfshoreHI@comcast.net
www.GulfshoreHI.com

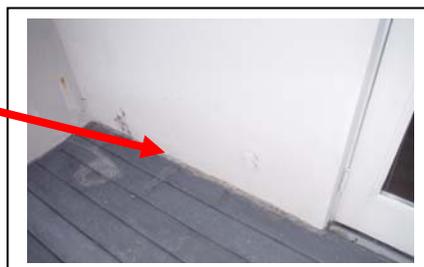
- At the 2nd floor right front guest bedroom balcony, the joint at the deck and wall of the home has been heavily caulked – see the picture below.

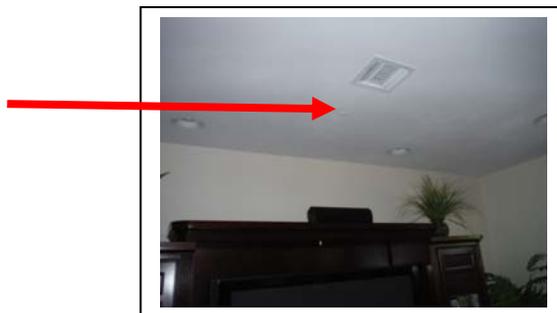
- The unit was very clean.
- The smell in the home was normal; there was no burning of eyes.
- The home was furnished; pictures on the walls, the closets were partially full of personal items in the corners and against the walls, the cabinets under the sinks were partially full. We do not move personal items.
- The thermal image scans revealed one moisture anomalies – see page 23 item #57.
- There is a bubbled spot on the 2nd floor theatre room ceiling just past the left A/C register; the area was dry and does not appear to be water related – see the picture below.

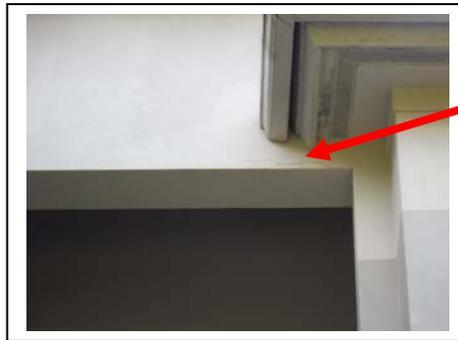
1. The front entryway header is cracked. We recommend this area be evaluated by a structural engineer. See the picture below.

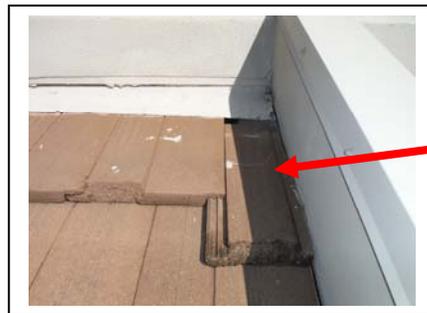
2. There is a slid down roof tile near the office balcony. See the picture below.

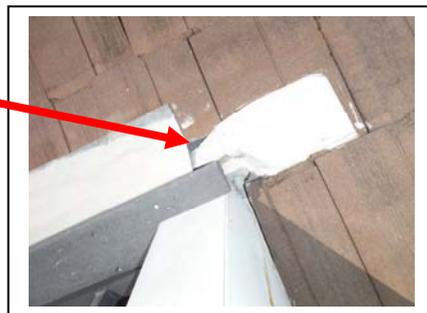
3. There is open flashing at the office balcony. (look over the rail) See the picture below.

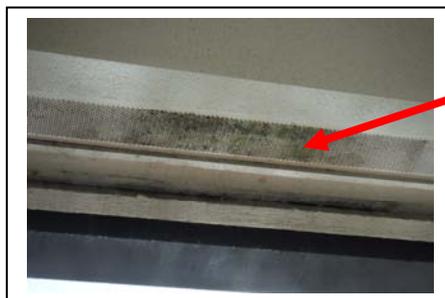
4. The lanai soffit and fascia board, directly below the office balcony, are stained. See picture below. This may indicate a roof leak or roof flashing issue. The roof tiles between the balcony and fascia have settled and the flashing has separated (see item #3). We recommend a licensed roofing contractor evaluate the deck roof.

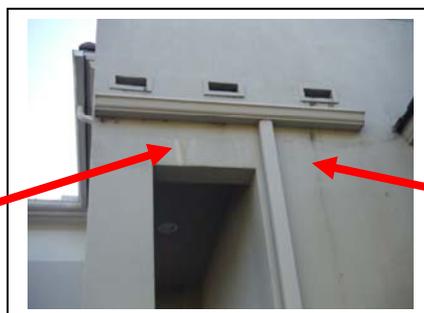
5. The driveway brick pavers on the left entrance and next to the mailbox have settled.
6. The exterior wall on the right end of the home, underneath the gutter off of the balcony, is stained and cracked; the gutter is no longer sealed to the wall (seen from the deck above the gutter) – see the picture below.

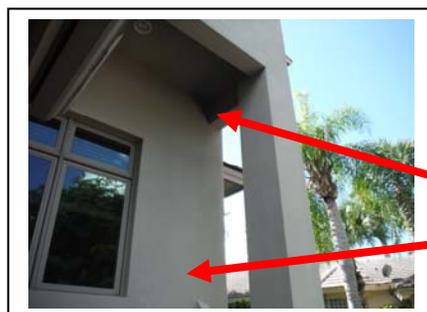
7. There are water stains running down the exterior wall outside of the laundry room; the stains are below the 2nd floor balcony on the right end of the home – see the picture below.

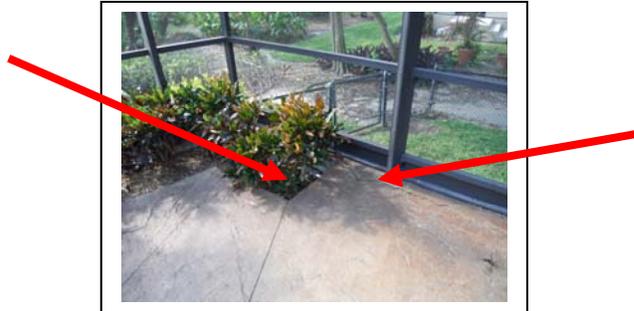
13. There is wood rot in the fascia board on the left end of the home above the rear set of stairs.
14. The two fence gates on the right side of the home do not latch properly.
15. The office active exterior door drags on the fixed door and the fixed door would not open.
16. At the family room left set of French doors, the fixed door drags on the threshold.
17. The 2nd floor center guest bedroom sliding screen door drags.
18. The lanai left screen door has a loose closure mount.
19. The lanai planter, at the right rear corner of the lanai, is losing soil; the lanai deck has cracked and shifted at this area – see the picture below for location. Could this be a broken sprinkler pipe?

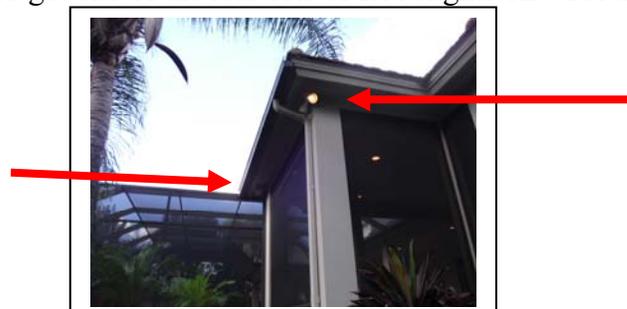
33. The 2nd floor center guest bedroom balcony soffit light is not working; check the bulb.
34. We were unable to get one of the rear sets of floodlights on – see the picture below.

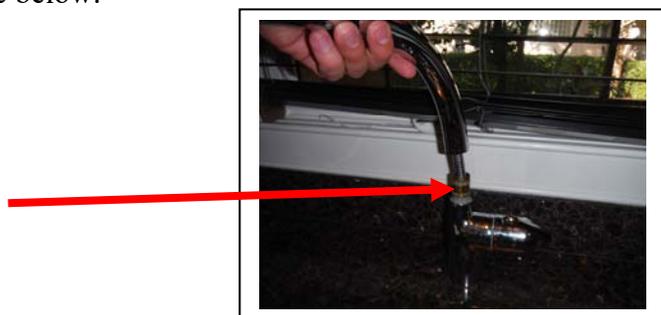
37. At the kitchen sink faucet, by the refrigerator, the faucet diverter button is not working.
38. At the kitchen sink faucet, by the refrigerator, the faucet neck is not secured to the base. See the picture below.

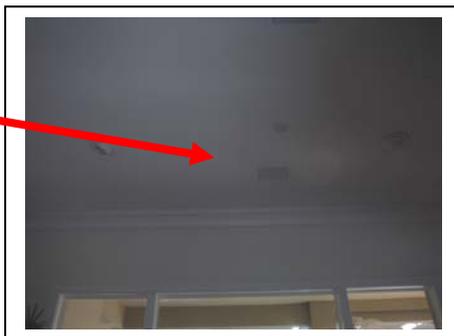
56. The laundry room wall, at the left end of the laundry room cabinets, is stained and damaged; the baseboard has been removed. The area was dry. The laundry room ceiling has a poor paint job; is this covering water issues? There is a flat balcony deck above this.
57. There is a water stain on the living room ceiling left of the speakers; the area is below the double doors to the rear balcony. The area was wet. This was confirmed with a moisture meter. See the picture below. We recommend a licensed roofing contractor evaluate the roof and balconies.

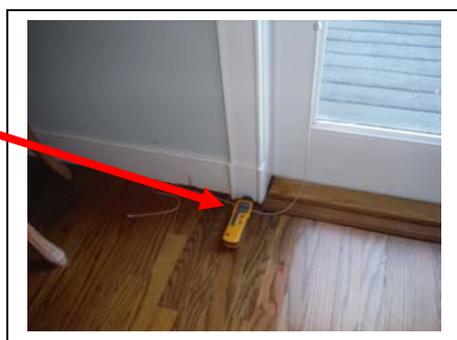
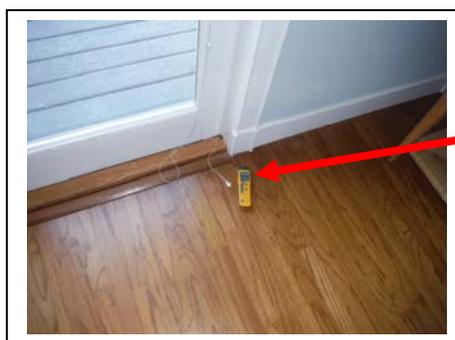
58. There is a water stain on the kitchen ceiling and wall above the ovens; the area was dry. This maybe from the upper deck which is in this area.
59. There is a water stain on the master bath ceiling above the tub; the area was dry.
60. There are two water stains on the master bath walk-in closet, under the stairs, ceiling; the area was dry.
61. There is water damage to the drywall left of the master bath shower; the area was dry.
62. There is a mold-like substance on the 2nd floor theatre room ceiling against the right A/C register. Clean.
63. At the 2nd floor right front guest bedroom, the wood floor at each end of the balcony French doors was wet. See the pictures below. This is related to the deck flashing.

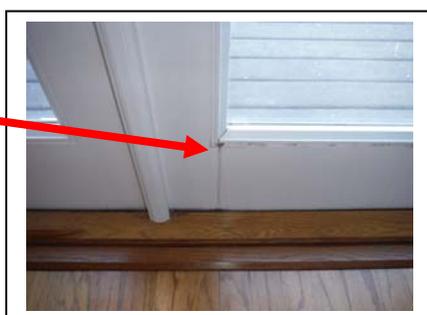
64. At the 2nd floor right front guest bedroom fixed balcony door, there is a water stain running down the door from the bottom left corner of the glass pane; the area was dry. See the picture below.

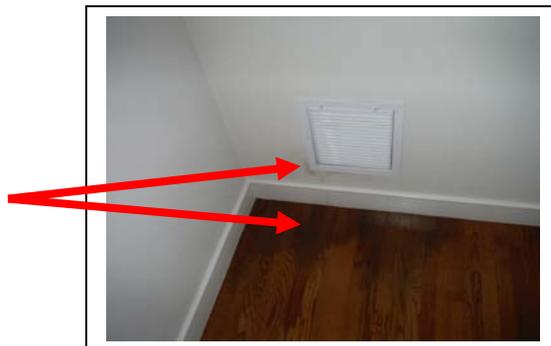
65. There is a water stain and mold-like substance on the 2nd floor theatre room wall at the A/C return air grill; the wood floor below the grill is stained. Both areas were dry. See the picture below. Clean.

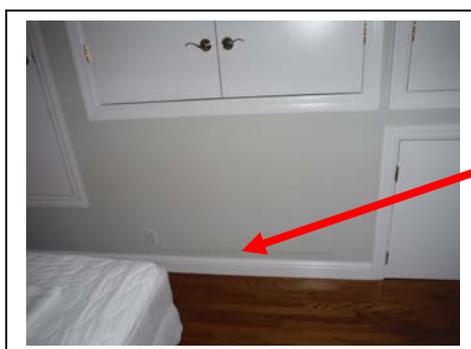
66. There is a water stain on the 2nd floor right rear guest bedroom wall between the A/C closets; the area was dry. See the picture below.
